Re: April 2013 Monthly Progress Report
Administrative Settlement Agreement and Order on Consent for Removal Action
U.S. EPA Region 10 Docket No. CERCLA 10-2009-0255
Gasco Sediments Site within the Portland Harbor Superfund Site

Visual Observations Log Form

Monitoring Period: Monthly (Year 7)—April 2013

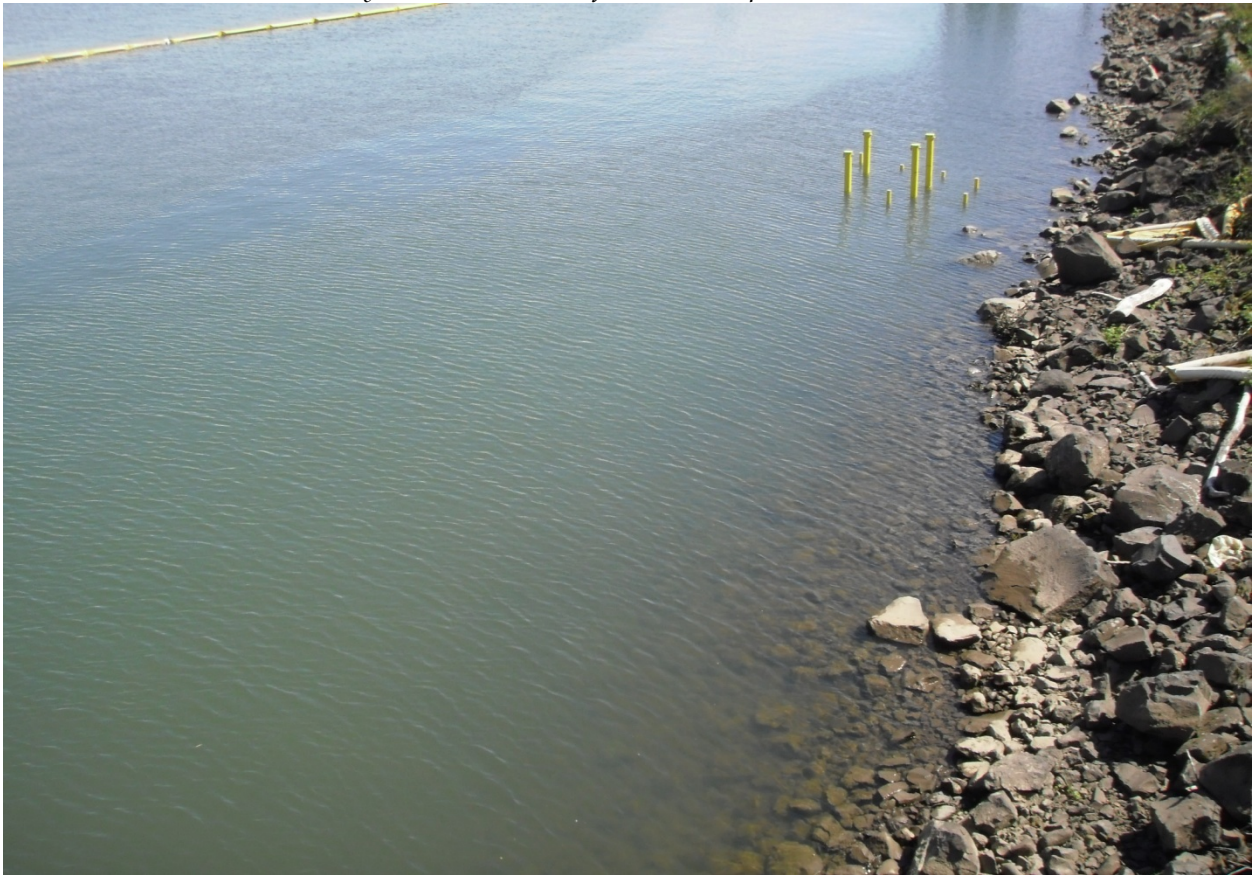
Observations of Erosion/Deposition: No erosion/deposition is evident along the shoreline. The shoreward extent of the cap was not visible due to high river water elevation and the extents of the organoclay mat material were also submerged. (Photo 1).

Photo 1 — *River level currently above the extent of sediment cap (4/16/13):*

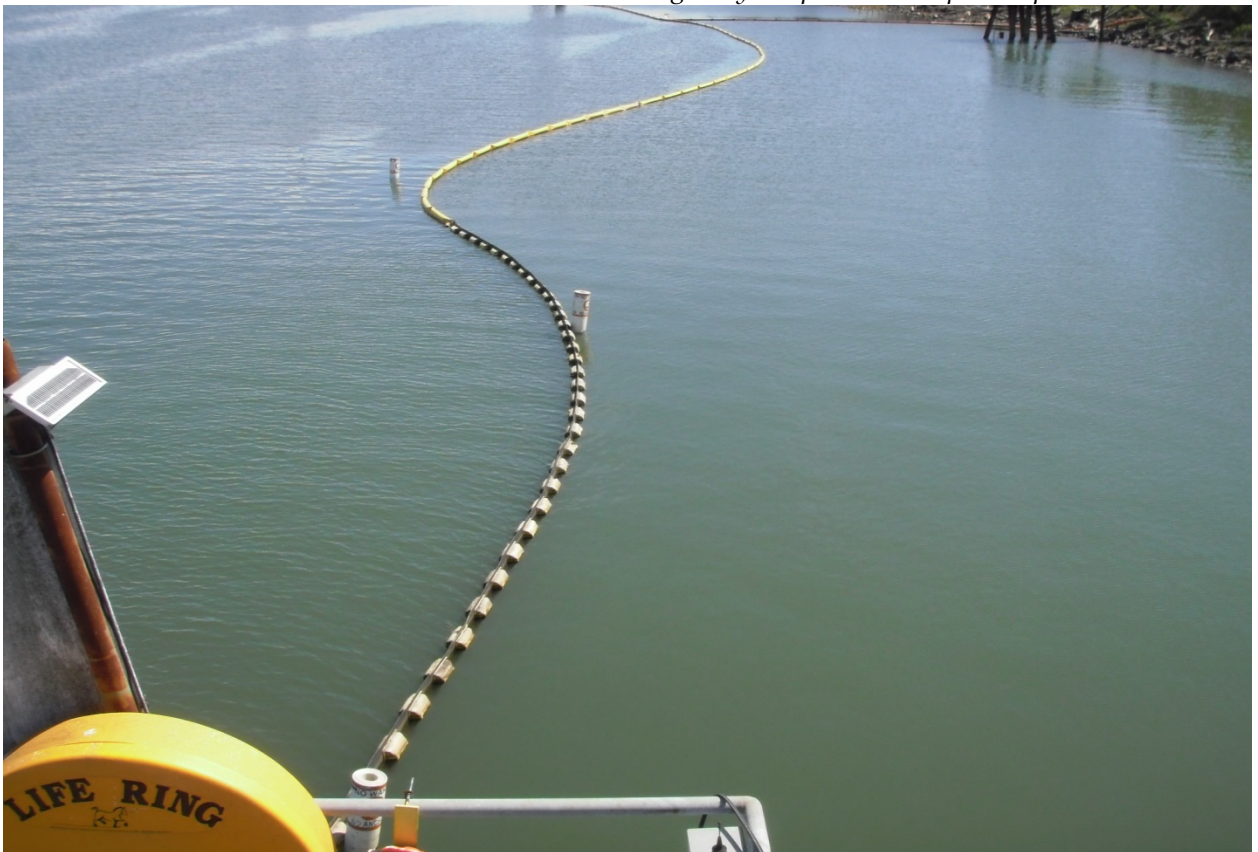
Observations of Long-term Controls (i.e., oil booms, organo-clay mat, etc.) During the observation, the Fuel and Marine Marketing (FAMM) containment boom was placed across the cap area, between the upriver corner of the ship dock and the wooden dolphin (near the upriver extent of the site and near the Siltronic Corporation outfall). Buoys that identify the cap area to mariners are in place as installed. The position of the FAMM oil boom, warning buoys, and a general overview of the site shoreline is shown in Photo 2.

Photo 2 — *FAMM oil boom shown and mariner warning buoys in place across pilot cap area. 4/16/13):*

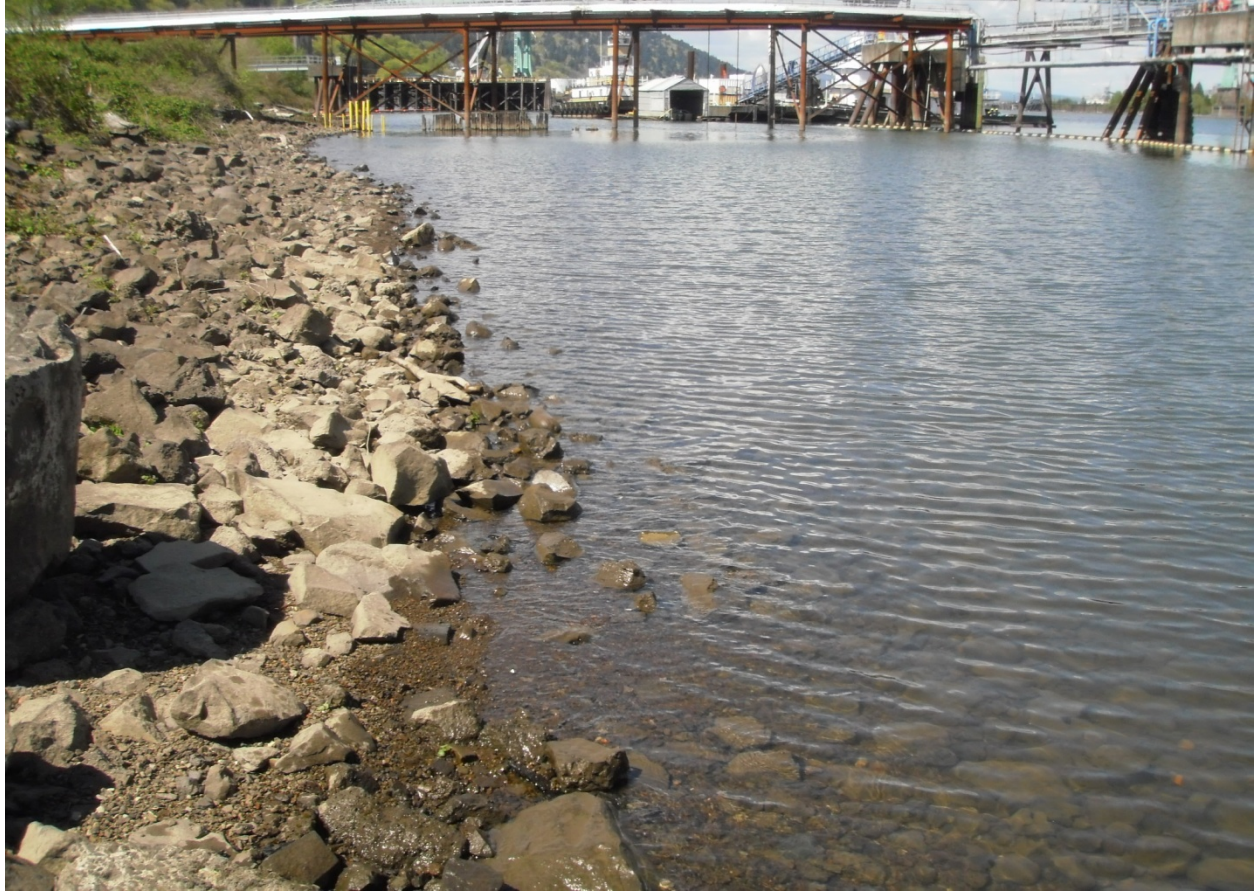
Other Comments: No sheen is evident in or around the cap area. Photo 3 shows the water surface and shoreline immediately downriver of the sediment cap.

Photo 3 — *Conditions immediately downriver of cap area (4/16/13):*
